THROUGH : Chief, Requirements Branch, Reconnaissance Group, CGS  
FROM : Chief, CIA/PID (NPIC)  
SUBJECT : Rail Study of Kuang-chou (Canton), China  
REFERENCES : (1) ORR Requirement C-RR3-80,542  
(2) CIA/PID Project No. C 1248-63

1. This memorandum is in answer to the above referenced requirement concerning a detail analysis of the rail complex serving Canton and its environs. This memorandum is the second and final part of the study covering this complex.

SUBJECT: Rail Study of Kuang-chou (Canton), China

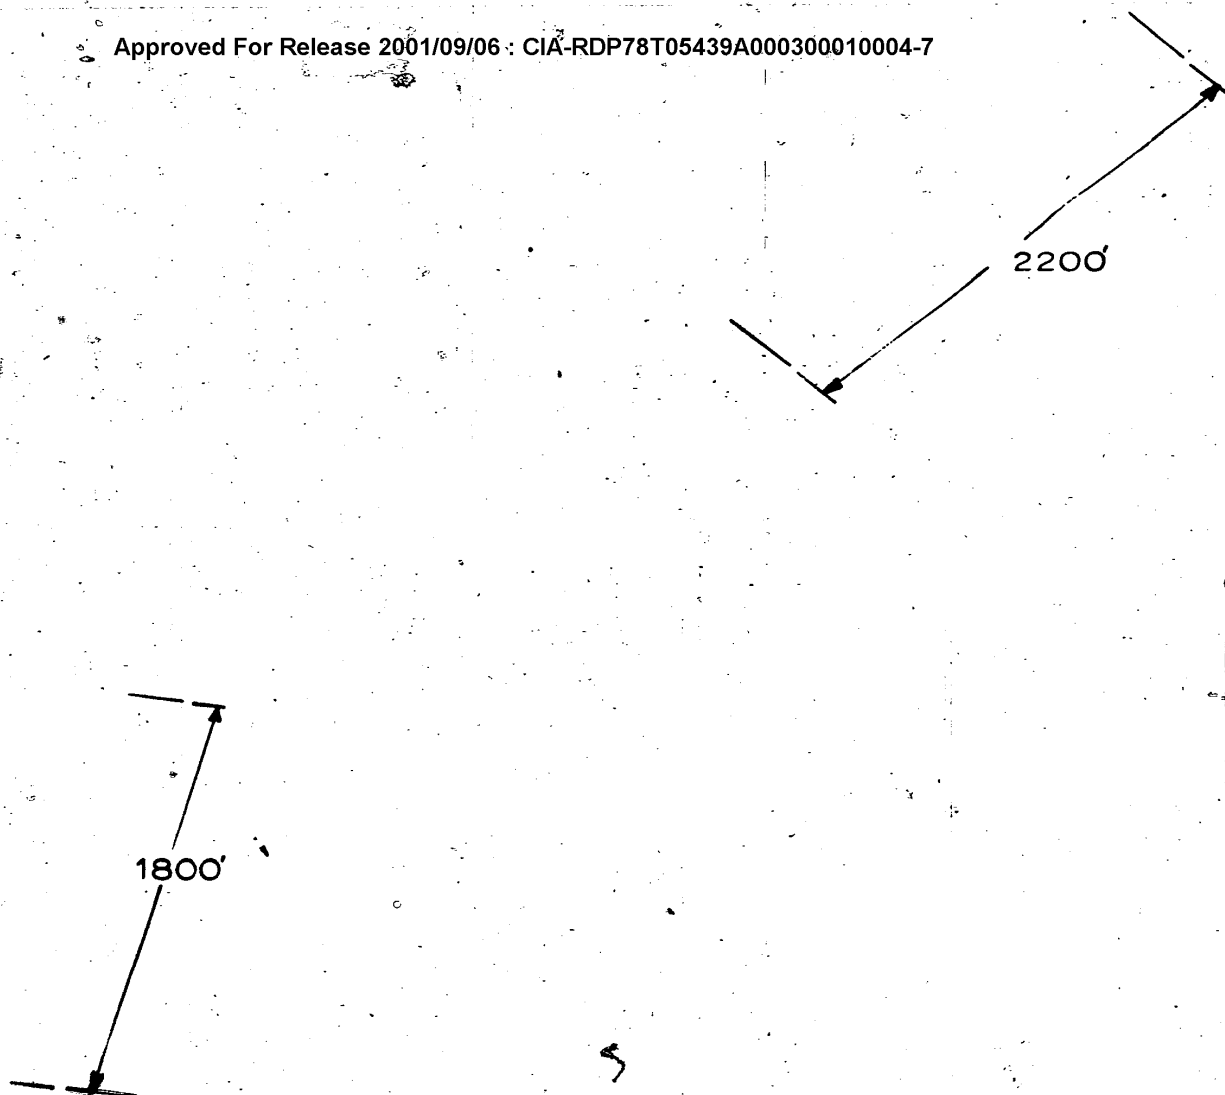
FIGURE #4

C. Probable transshipment area and yard (See Figure 4). This area is essentially the same as it appeared in [REDACTED] except the rail spur annotated "B" is a new development. A possible station may be associated with the yard shown in the upper right portion of Figure #4.

PROBABLE TRANSHIPMENT AREA  
23° 09'N - 113° 17'E

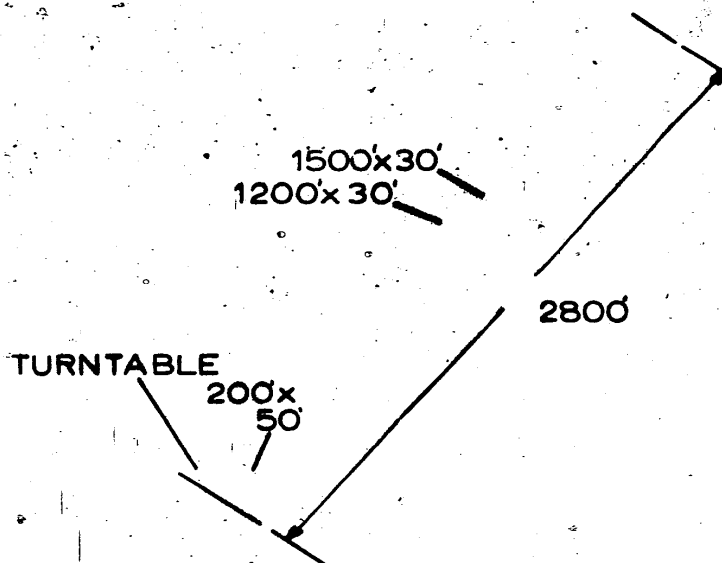
FIGURE #5

25X1D d. Passenger station and car maintenance area, this may be the Kuang-chou Railroad Repair Shops SE [REDACTED] (See Figure 5). This area consists of a large passenger station and several buildings probably engaged in passenger car maintenance activity. Since [REDACTED] the large (1500' in [REDACTED] building was extended to its present length; a long building north of the 200' x 50' building in the car service area has been removed; and several small buildings have been added in the service area. Several maps indicate rail spurs branching from this line between the rail terminus and the intersection with the mainline, this section of rail appears to be clean of any old or new rail spurs branching from the line (as is indicated on Figure 1).

PASSENGER STATION  
AND CAR MAINTENANCE  
(Prob. Kuang-chou RR Repair  
Shops SE [REDACTED]  
23° 07'N - 113° 16'E

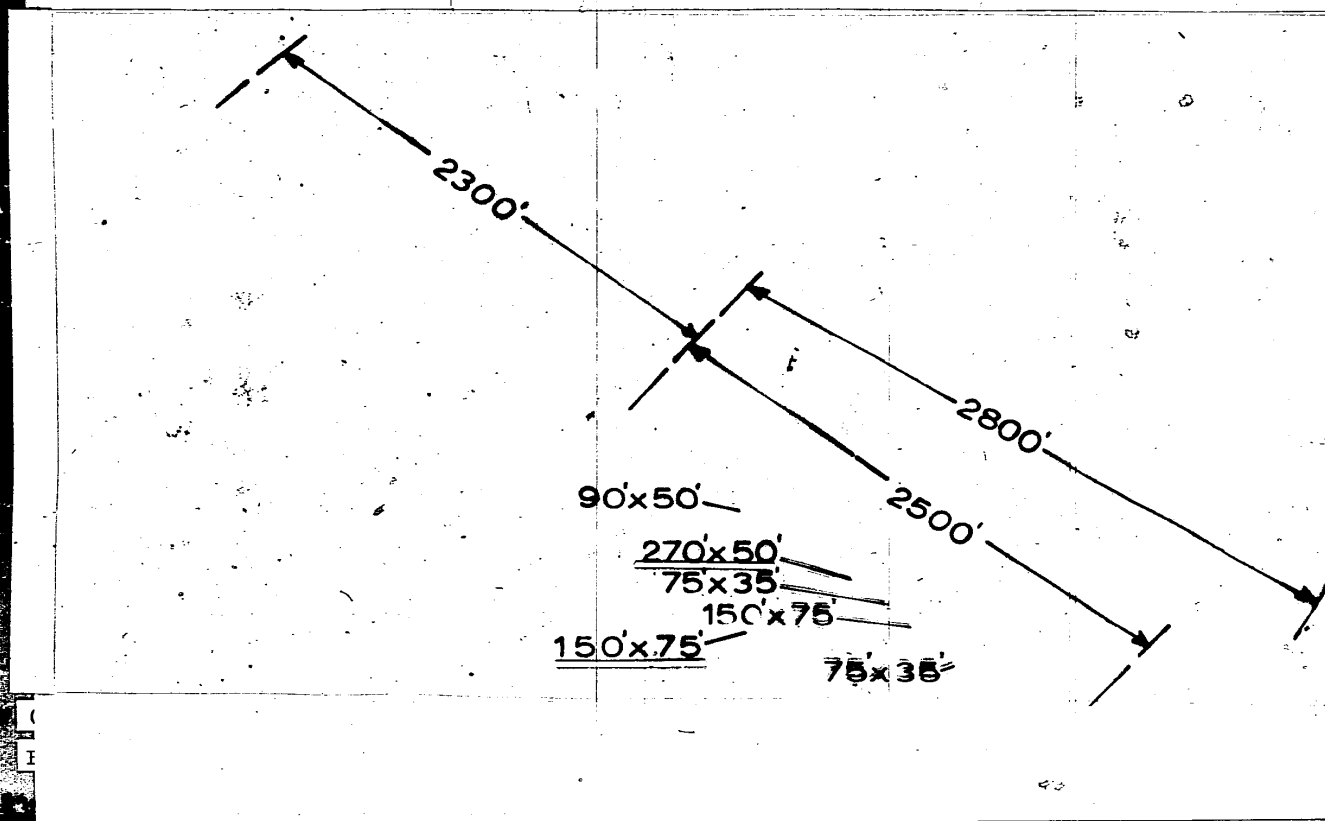
FIGURE #6

e. The Kuang-chou Railroad Classification Yards, Wong-sha (See Figure 6). This area is essentially the same as it appeared in [REDACTED] except:

(1) The coal handling and storage area appears to have shifted from this area to the newly constructed yards at the Huang-pu Railroad Terminal Yard. For the comparison between [REDACTED] and [REDACTED] compare Figures 6 and 8. For comparison of the Huang-pu Yards see Figure 7.

(2) Minor additions have been constructed in the western part of the yard. These being maintenance/storage-type structures, two of which are underlined by tape on the accompanying overlay to Figure 6.

(3) A large area has been reclaimed from the river just northwest of the yard area. This area will probably be used as a storage area and probably for small industries is indicated by new construction there on the later photography. (See Item "A" Figure 6).

(4) Only one major change has developed in the rail-to-river traffic, this is the addition of two probable grain handling facilities as indicated by Item "B" on Figure 6.

KUANG-CHOU RR CLASSIFICATION  
YARDS, WONG-SHA
